MGB Restoration

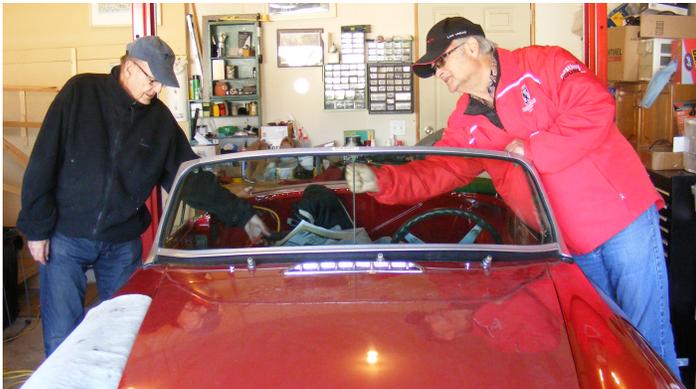
A daunting job was the replacement of the windshield frame in to the car body. I'd read many stories of just how difficult this could prove to be. But I followed a tip I'd read somewhere about first wrapping the screen with 90 pound test fishing line, spaced about every 2 inches, to counteract the force of the

lower seal. Gord and Howard held the frame for me while I wrapped the line around and tied it off. I had started this process weeks earlier but discovered that the windshield glass was not centered in the frame so I took it to Crystal Glass to get it refitted properly. We lowered the screen in to place and used a long center punch to locate the bolt holes inside the cockpit. The process went much faster than I expected. With bolts in place and tightened, we cut and removed the fishing line and the seal fell into place.
